**REMOVAL PROGRAM
PRELIMINARY ASSESSMENT/
SITE INVESTIGATION REPORT
FOR THE
ANGLO ENTERPRISES COMPANY SITE
WEBSTER, WORCESTER COUNTY, MASSACHUSETTS
10 NOVEMBER and 1 AND 2 DECEMBER 2015**

March 2016

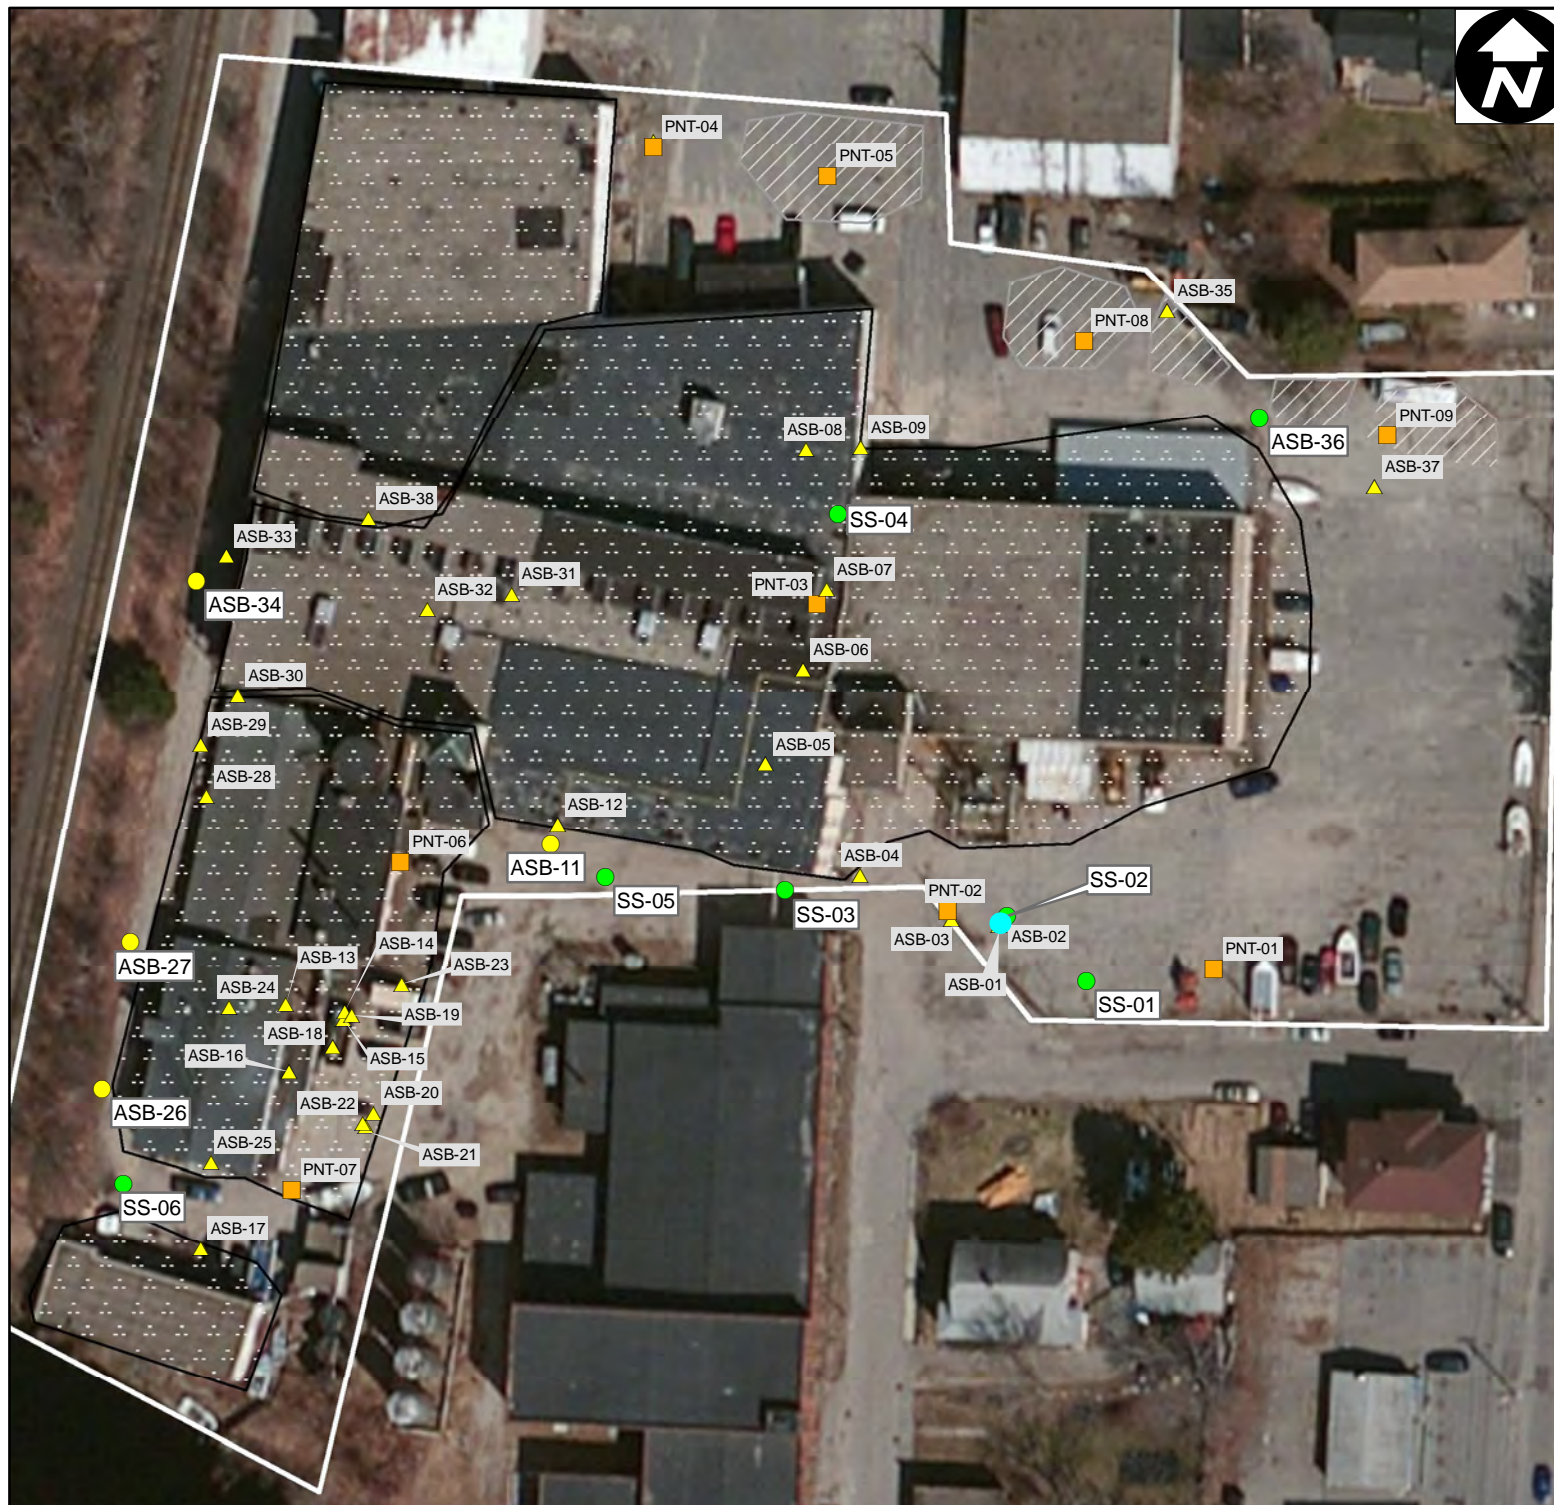
Figure 3

ASB-30	0077-0030	PACM	Burnt pipe wrap, collected from the western edge of the main debris pile.

SS-02	0077-0040	Soil	Stained soil, collected from the southern border of the site.	
SS-03	0077-0041	Soil	Soil sample, collected from the southern boundary of the site, near the remaining mill building.	
SS-04	0077-0042	Soil	Oil/solids collected from machinery in the center aisle of the main debris pile.	
SS-05	0077-0043	Soil	Stained soil, collected from the southern border of the site.	
SS-06	0077-0044	Soil	Stained soil, collected from the vicinity of the large tank in the southwest corner of the site.	
PNT-01	0077-0045	Paint	Paint from an I-beam on the southeastern portion of the site.	
PNT-02	0077-0046	Paint	Paint from an I-beam on the southeastern portion of the site.	
PNT-03	0077-0047	Paint	Paint from a door in the center aisle of the main debris pile.	
PNT-04	0077-0048	Paint	Paint from the stucco wall covering on the north side of the site.	
PNT-05	0077-0049	Paint	Paint from an I-beam in the eastern steel pile on the northern side of the site.

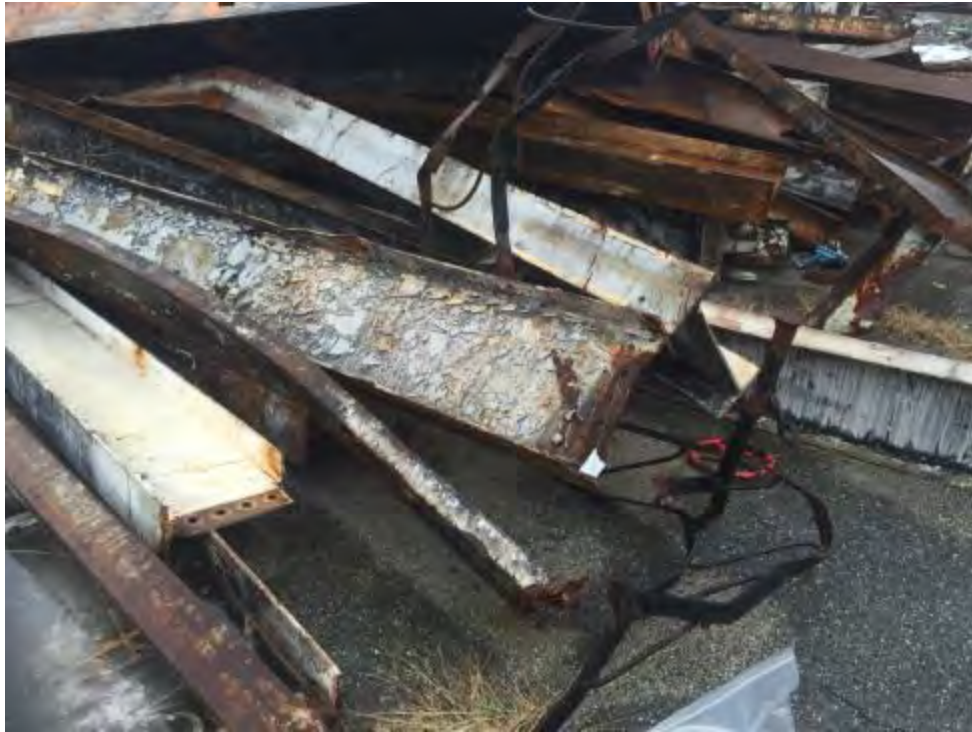
SCENE: View of paint chips on I-beams (typical) at paint chip (PNT) sample location (PNT-02). Photograph taken facing north.

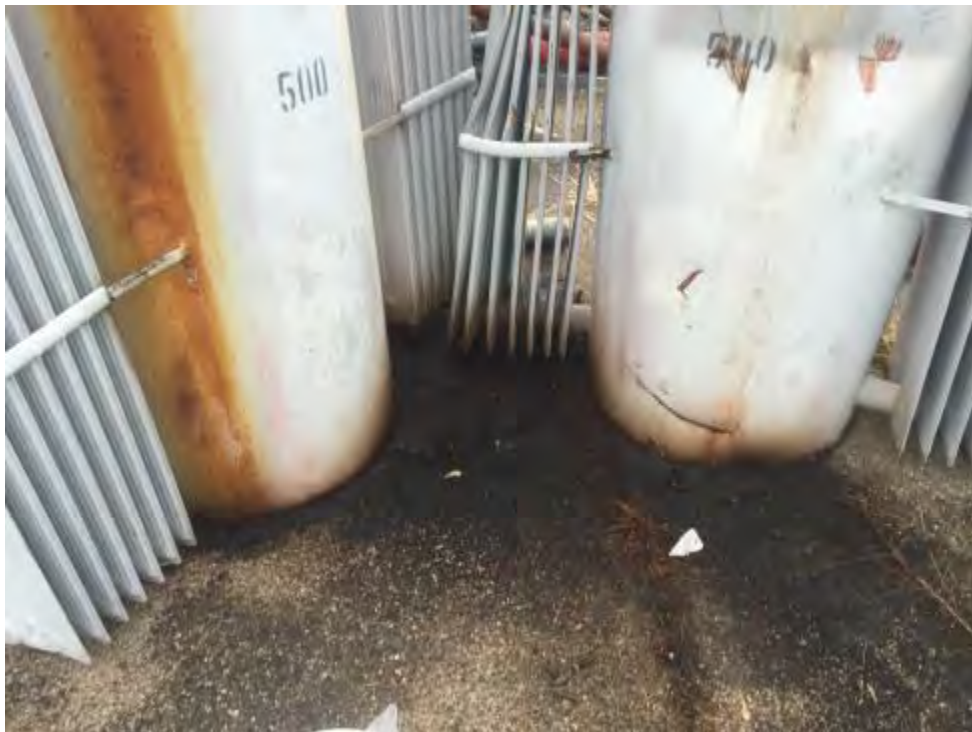
SCENE: View of damaged transformers staged on site and polychlorinated biphenyl (PCB) soil sample (SS) location SS-01. Photograph taken facing southeast.

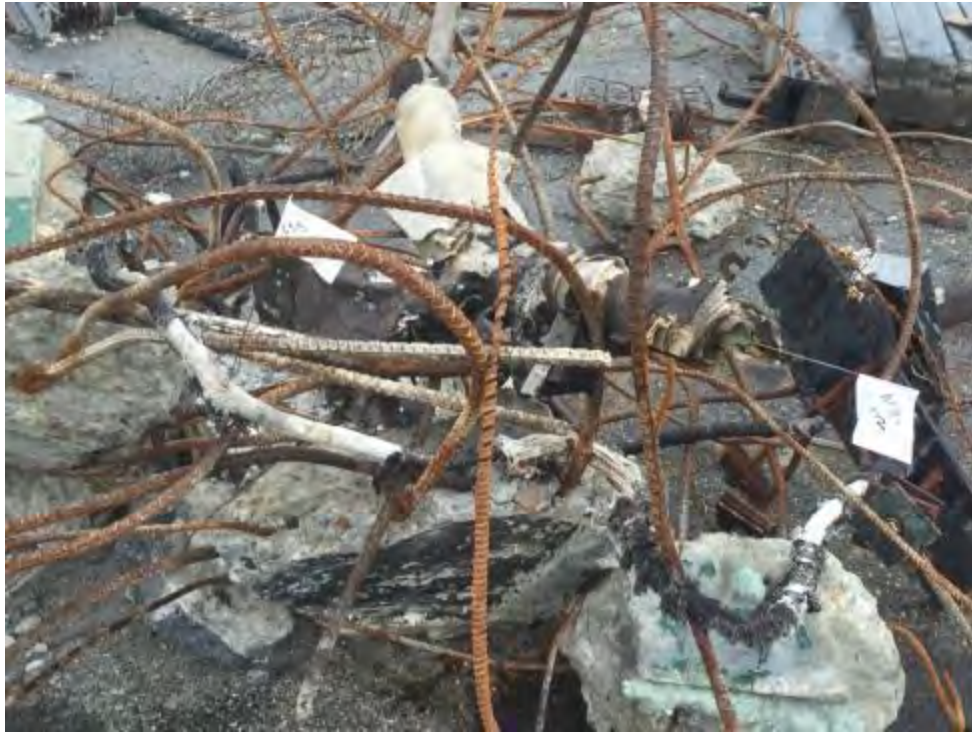
SCENE: View of suspected asbestos-containing material (ACM) asbestos (ASB) sample location ASB-02.

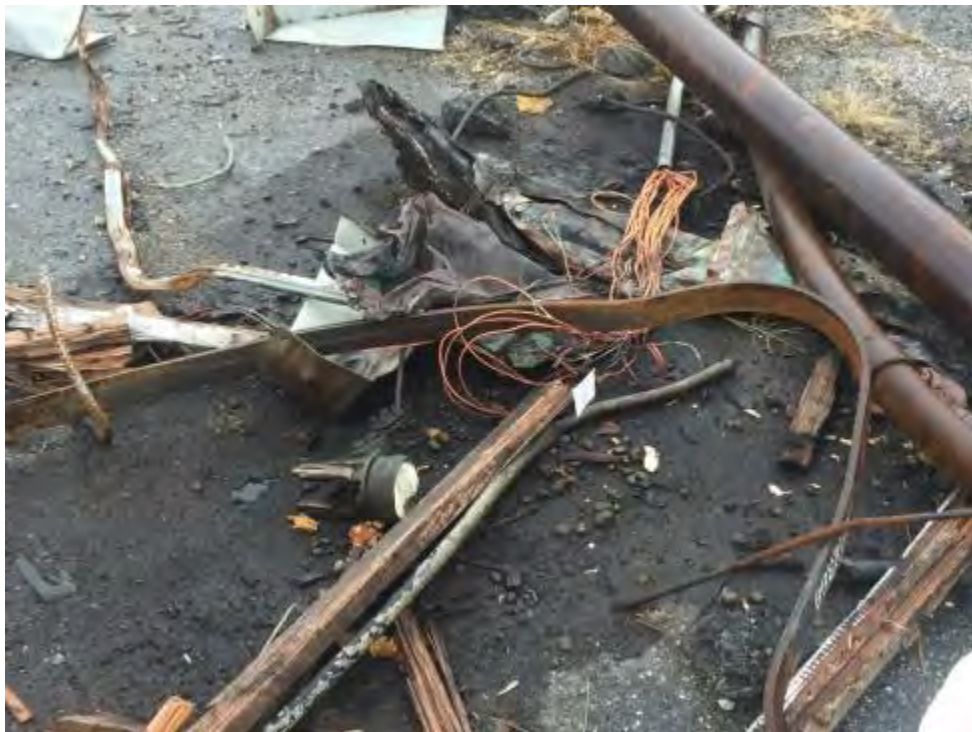
SCENE: View of PCB soil sample location SS-02.

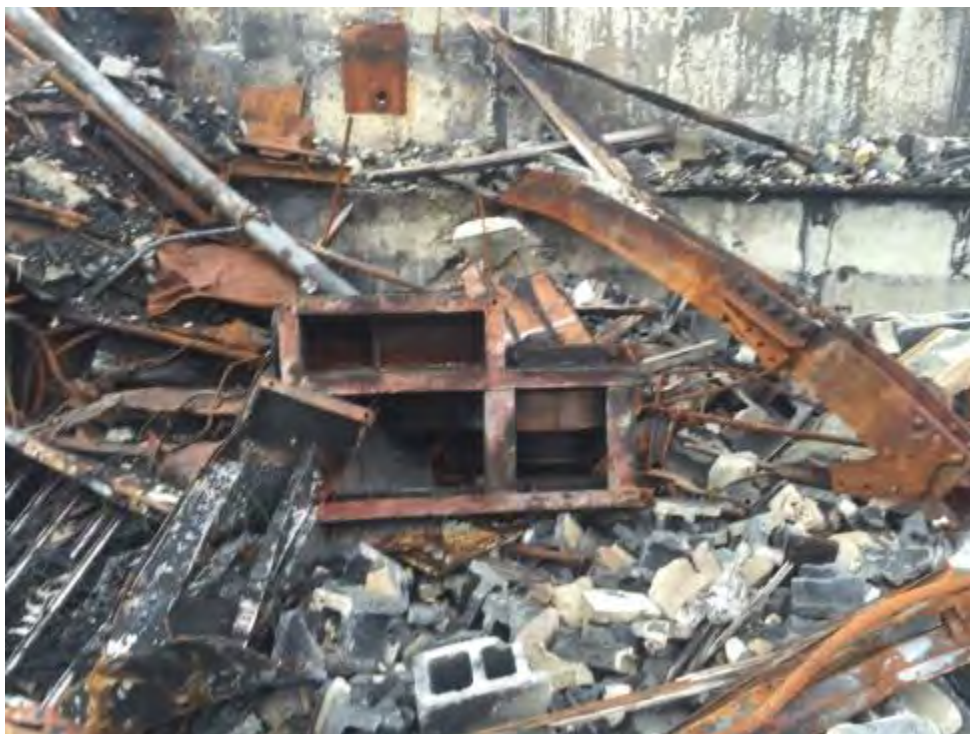
SCENE: View of sample location SS-04. Photograph taken facing east.

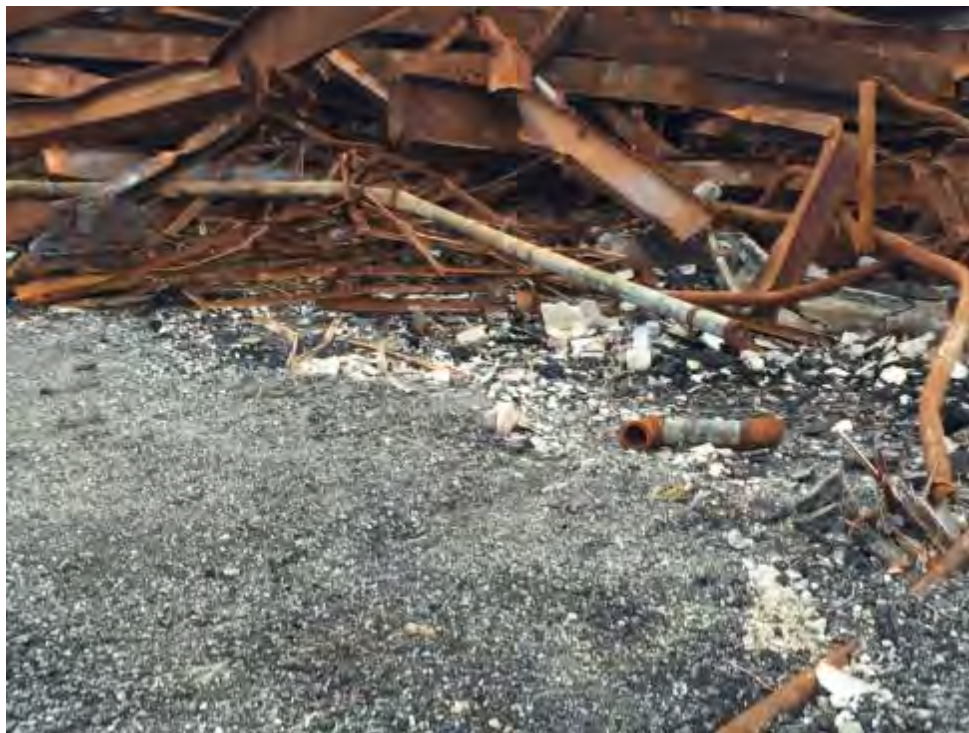
SCENE: View of sample location ASB-12. Photograph taken facing northwest.

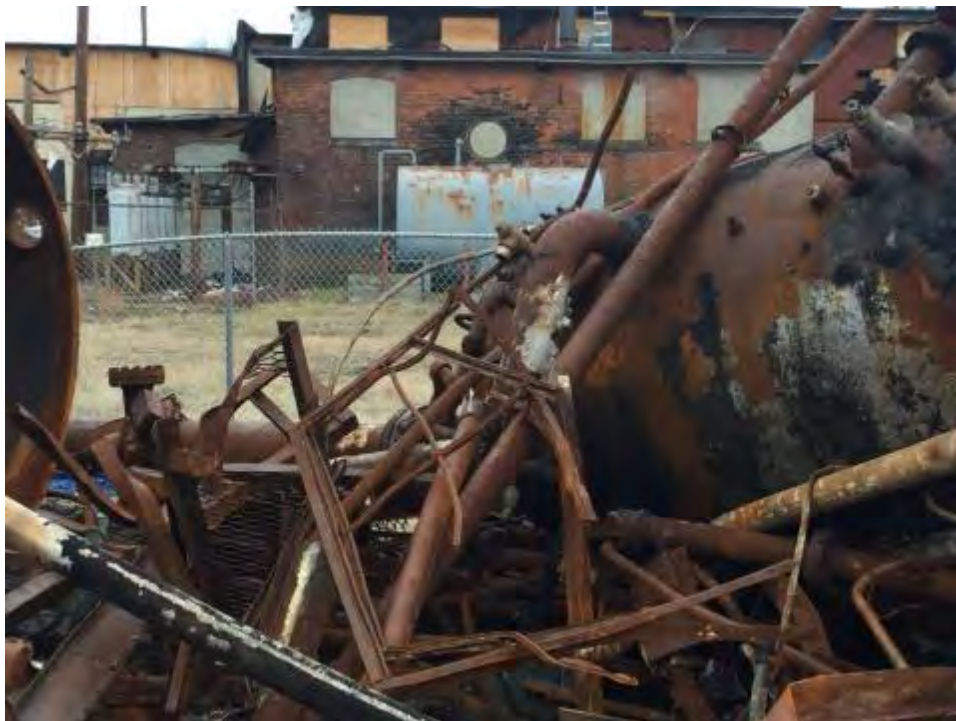
SCENE: View of boiler and boiler debris. Photograph taken facing east.

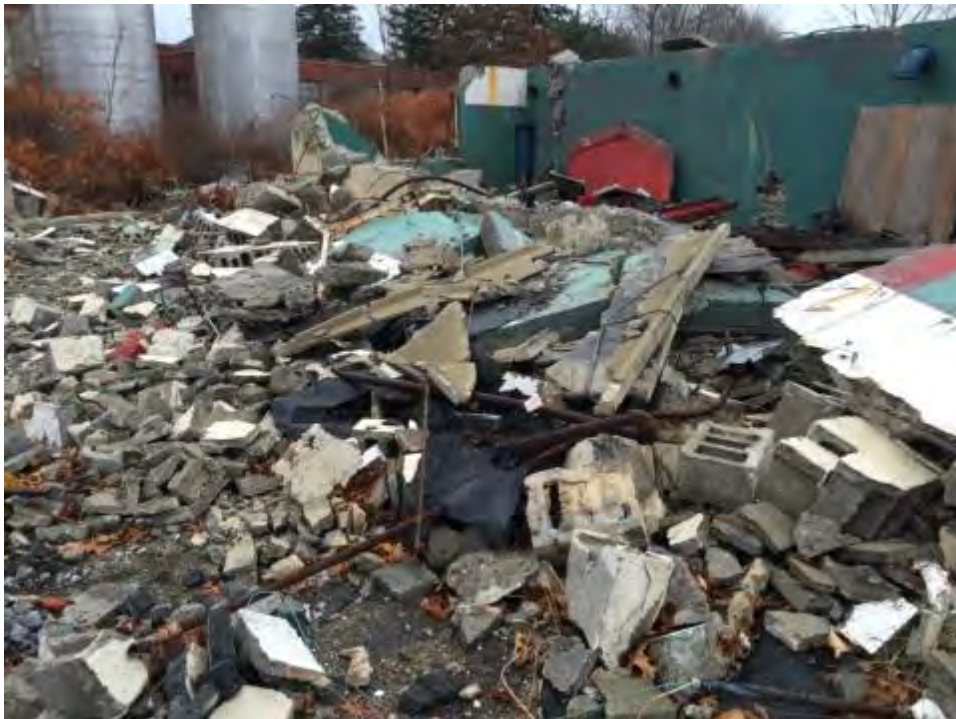
SCENE: View of sample location ASB-17 (roofing material). Photograph taken facing southeast.
